Report Master
Inspections

Pest Inspection

VISUAL TIMBER PEST INSPECTION REPORT as per AS4349.3-2010

Visual Pre Purchase Pest Inspection in accordance with AS4349.3.

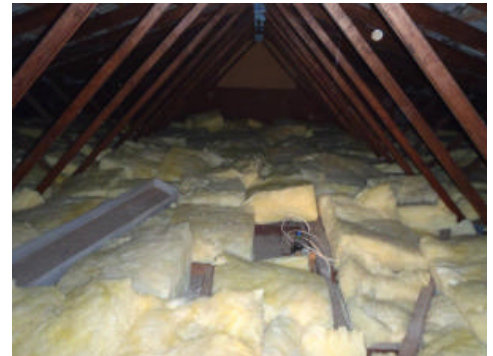
Insulation is present in the roof cavity. This restricted inspection to some roofing timbers. Removal of insulation is not within the scope of a standard visual timber pest inspection report however, this would be necessary for a more complete report to be submitted.

Sarking paper covered tile battens restricting inspection.

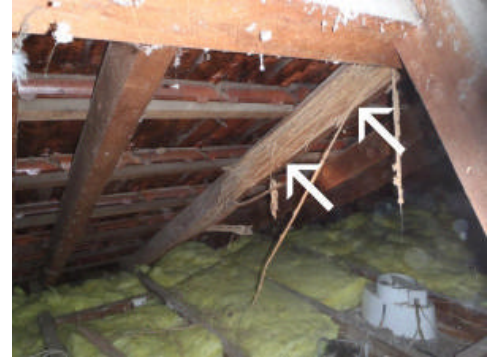
Various areas of the roof void:

Yes - Inspection revealed currently inactive termite attack (damaged timbers and/or termite workings) within this area including but not necessarily limited to the following timbers and the areas listed below. Also refer to section 5.0 (Evidence of Termite Damage) at the end of this report.

Rafters:

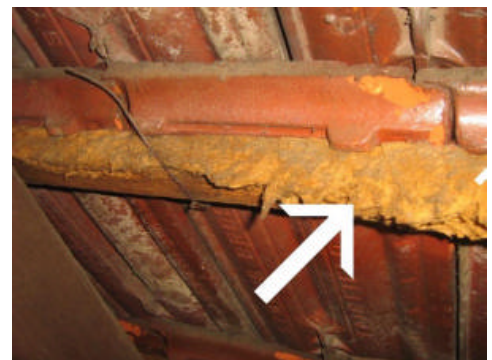
Bathroom: Main bedroom:

Visible timber damage appears moderate to severe however, we are not builders and this is not to be considered a builder's opinion. Refer to the definitions section of this report - Section 1.6 - Timber Damage.

Yes - Defibration was noted to some roof timbers. This is a cellular breakdown of the timber caused by the exposure to either salt air or industrial fallout (eg. motor vehicle gases). This is an extremely slow process and no chemical treatment is applicable. In rare instances with small diameter timbers such as tile battens, defibration can cause these timbers to fail over time.

Tile battens:

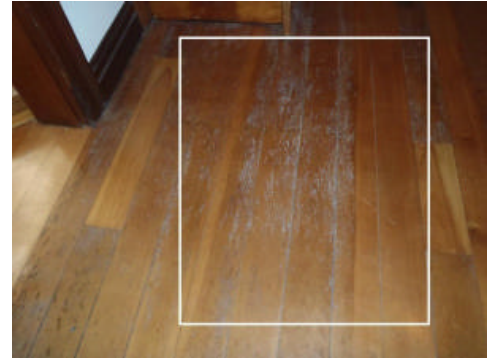
Yes - Anobium borer damage was noted to the following timber(s)/area(s). Without destruction of the timbers it is not possible to determine whether activity exists or the extent of timber damage within.

Anobium borer damage was noted to flooring timbers. See summary regarding treatment options.

Flooring timbers:

Anobium punctatum borer damage is evident to softwood flooring. It is not possible to determine whether activity exists without destruction of the timbers. We recommend that it would be prudent to assume that current borer activity is present unless written evidence is available to indicate that the property has been recently treated in respect to this borer. Replacement of affected timbers is always preferred as a long term solution however, a chemical treatment to control re infestation may be considered a less effective and lower cost option. This treatment is applied to the underside of all soft pine flooring timbers. We recommend you contact a pest firm to discuss treatment options and costs.

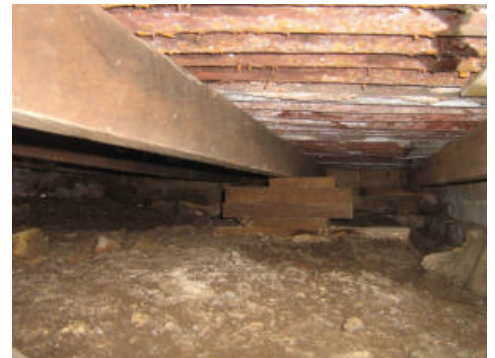
Lounge room: Dining room: Hallway:

Visible timber damage appears moderate to severe however, we are not builders and this is not to be considered a builder's opinion. Refer to the definitions section of this report - Section 1.6 - Timber Damage.

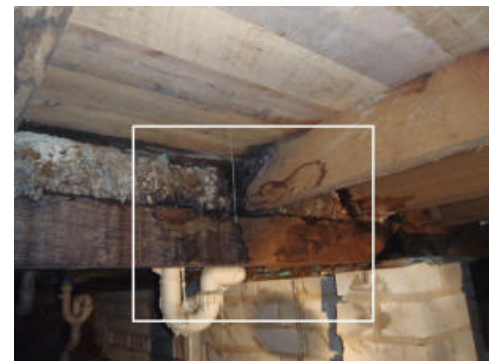
Yes - Fungal Decay (wood rot) was noted to the following timbers/areas.

Bearers: Floor joist/s:

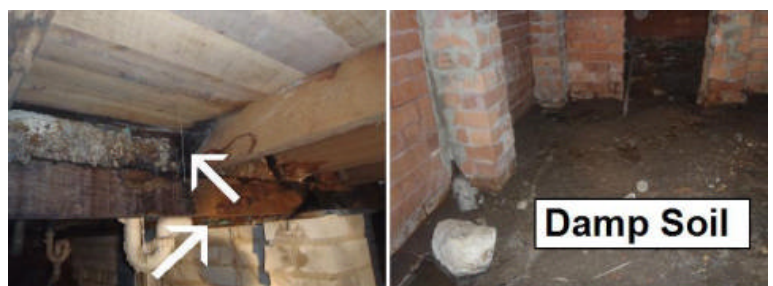
Main bathroom:

Visible timber damage appears moderate however, we are not builders and this is not to be considered a builder's opinion. Refer to the definitions section of this report - Section 1.6 - Timber Damage.

A water leak appears to be present in this area. This should be investigated and rectified. Areas of free moisture should be investigated and rectified as moist conditions are highly attractive to subterranean termite attack. Leaks from showers or other 'wet areas' also increase the likelihood of concealed termite attack.

We note that some of the ant capping has rusted and deteriorated. The purpose of ant capping is to reduce the risk of concealed termite attack. Ant capping should be repaired or installed where possible. If this is not possible, regular inspections are recommended. Missing, damaged or poor termite ant capping increase the risk of termite infestation.

Water is ponding on the soil within the underfloor area. This may be due to a drainage problem or some other factor. This should be rectified as moist soil conditions are highly conducive to timber pest attack. Poor drainage, especially in the subfloor, greatly increases the

likelihood of wood decay and termite attack. We claim no expertise in plumbing and drainage, however it may be that the drainage is inadequate and in need of improvement.

Some underfloor timbers are in contact with soil. These should be modified so that timber to soil contact does not occur.

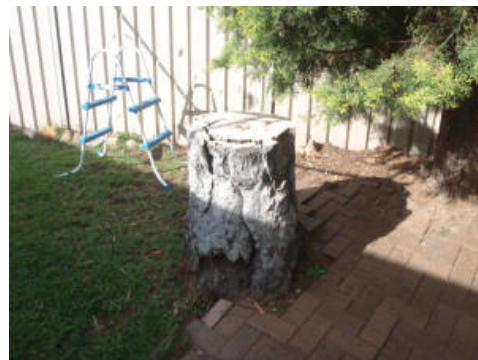
Tree stumps should be removed. This is because tree stumps left over time can be highly attractive to subterranean termites.

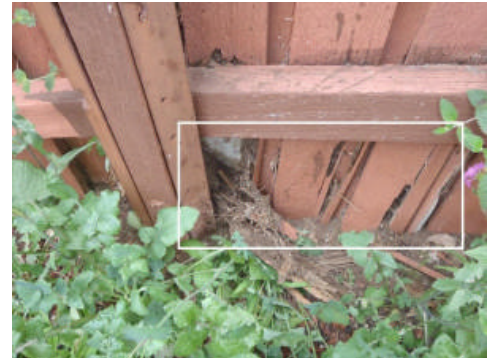
Right hand side fence:

Yes - Inspection revealed currently inactive termite attack (damaged timbers and/or termite workings) within this area including but not necessarily limited to the following timbers and the areas listed below.

Visible timber damage appears moderate to severe however, we are not builders and this is not to be considered a builder's opinion. Refer to the definitions section of this report - Section 1.6 - Timber Damage.

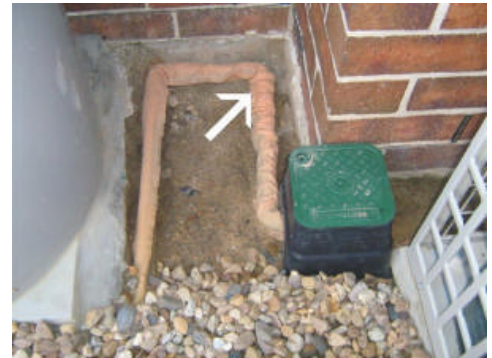
There is a termite reticulation system is present. Termite reticulation systems installed during or after construction to assist in the protection of the structure against subterranean termite attack. We strongly recommend any prospective purchaser attempt to verify these findings and obtain all relevant documentation in relation to this system.

NOTE: Sections of the reticulation system are exposed. This system does not currently comply with the manufacturers installation guidelines. We strongly recommend that a suitably qualified pest firm be engaged to check the entire system and carry out any repairs or remedial action required.
